Geotechnical Investigation Report:

Lunar Exploration Ground Sites (LEGS) Communication Facility

Matjiesfontein, South Africa

Report no.: 23123G-02(0238-RP-Rev0)

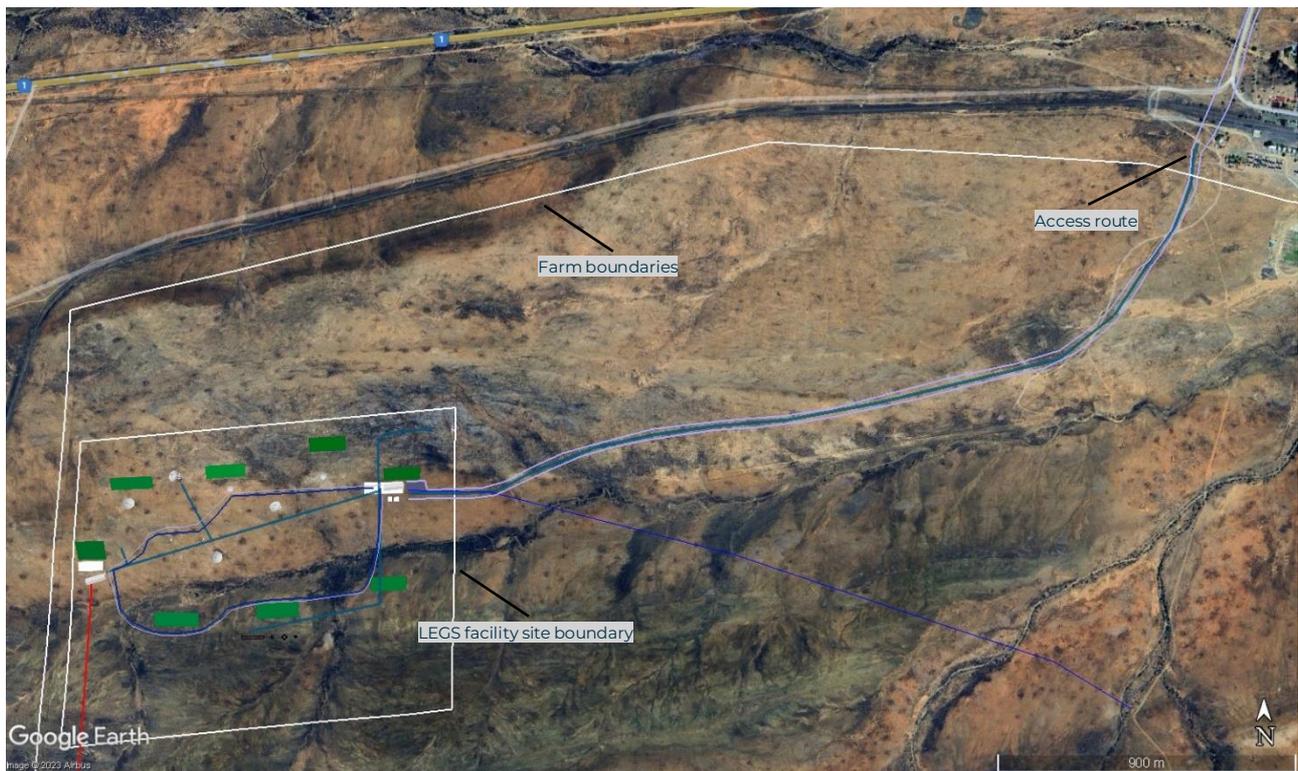
Figure 1-1 Proposed development

- Operations building
- Power room building
- Approximately three (3 No.) telecommunications dishes of various sizes ranging between 10 m and 34 m in diameter
- Solar PV facility/s
- Associated infrastructure such as roads and pavement, underground and overhead transmission and communication lines and water infrastructure

The proposed communication facility layout is presented in Figure 1-1.

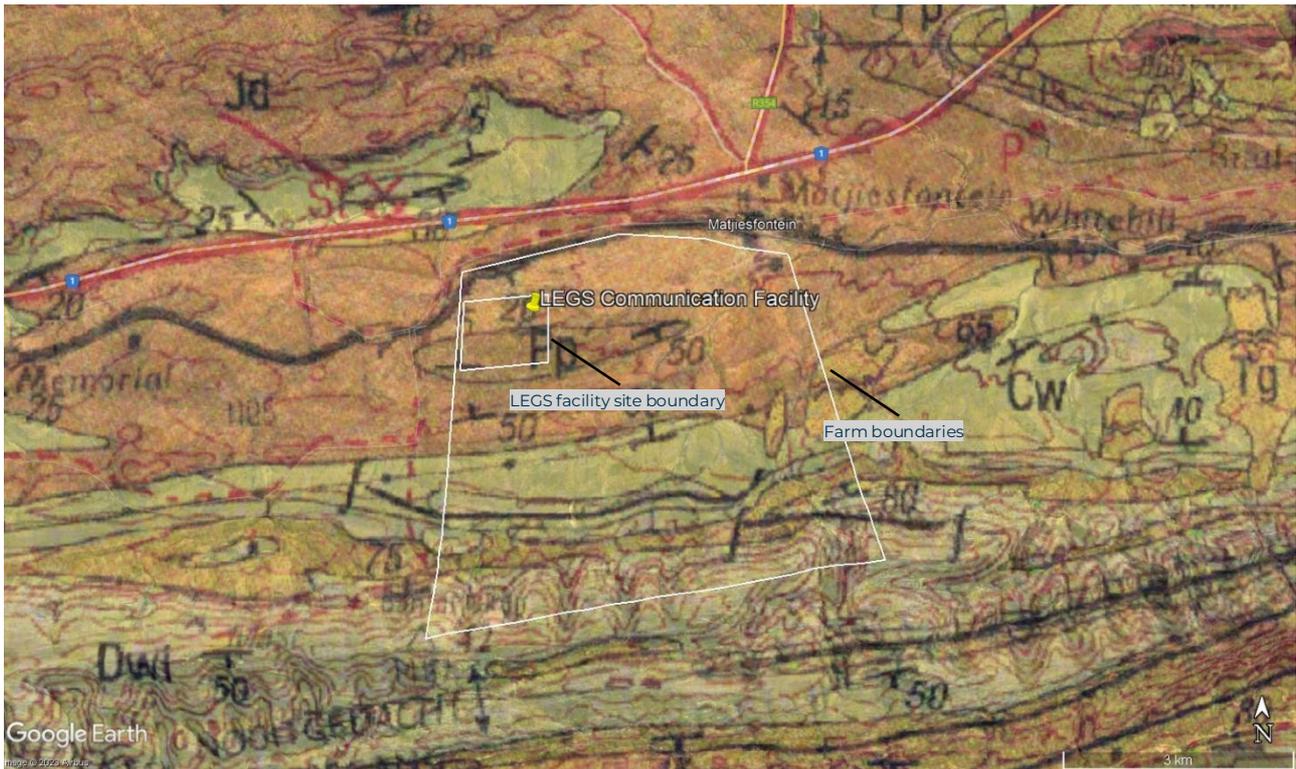
Figure 2-2 Extract from the 1:250 000 scale Geological Map 3320 Ladysmith

The bedrock within the site was variably overlain by hillwash (sediments transported largely by sheet flow) and alluvium within the valley. The site location is illustrated on an extract of the 1:250 000 geological sheet 3320 Ladysmith in Figure 2-2.

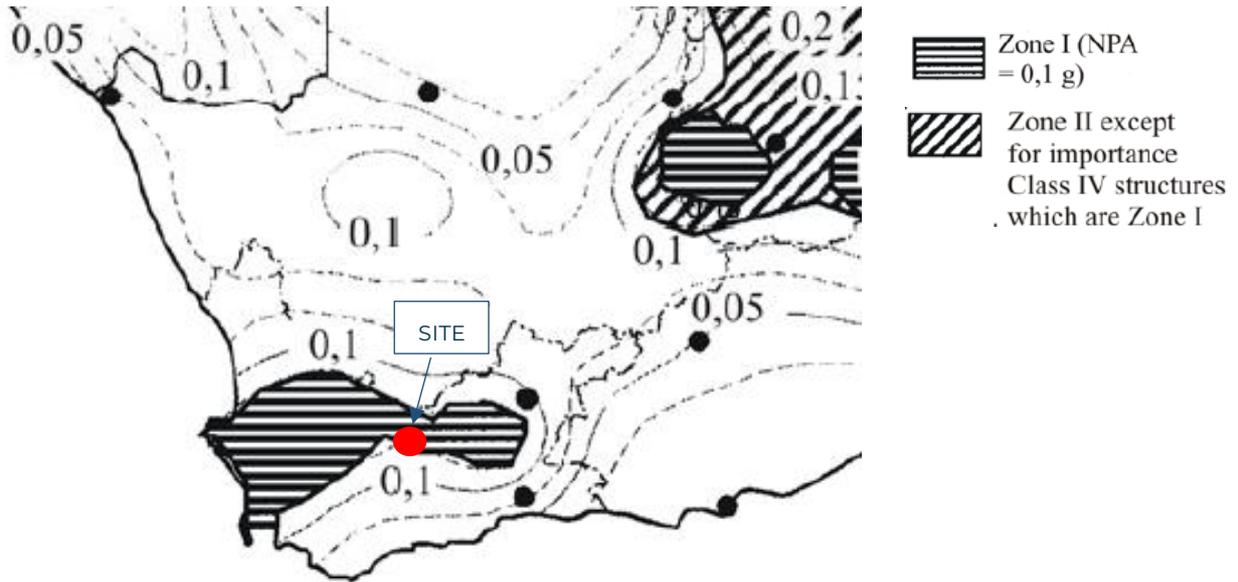
Figure 2-3 Extract from SANS 10160, Seismic Hazard Map of South Africa

Seismically active areas in South Africa are divided into two groups in SABS 10160 “Basis of structural design and actions for buildings and industrial structures — part 4: seismic actions and general requirements for building”, namely those where seismic activity is due to natural seismic events (Zone 1 areas), and those where it is predominantly due to mining activity (Zone 2 areas). As indicated in Figure 2-3, which is extracted from SANS 10160, the site falls on the boundary of Zone 1 of the seismically active south-western part of the Western Cape Province. In absence of a detailed Probabilistic Seismic Hazard Assessment (PSHA) study, provision should be made for seismic loading in the design of the foundations as per a site within Zone 1.

According to the Seismic Hazard Map of South Africa contained in SANS 10160 the peak ground acceleration (g) with a 10% probability of being exceeded in a 50-year period in the Matjiesfontein area is in the order of 0.1 g, which would be considered a moderate hazard. The ground type is Type 1 which is characterised by shallow rock and other rock like geological formations, including at most 5 m of weaker material at the surface.

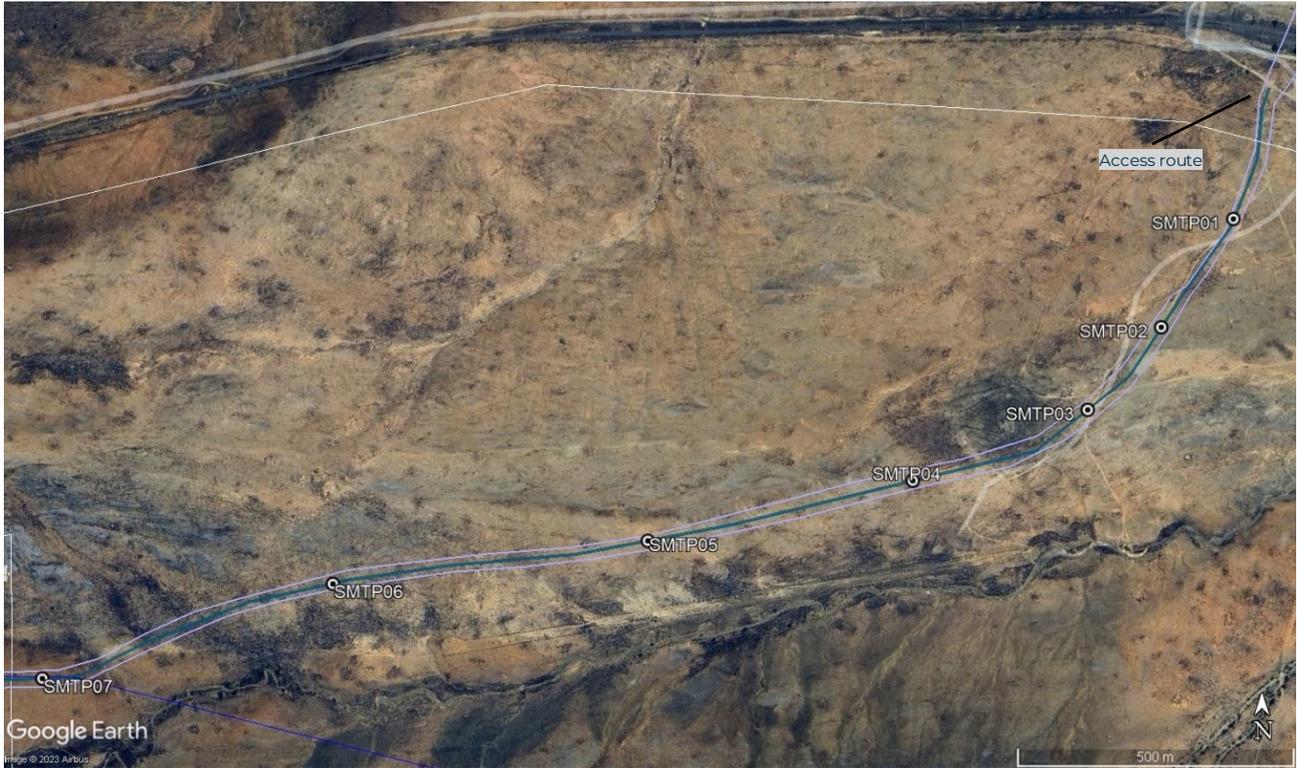
Figure 3-1 Location of test pits along the proposed access road (SMTP01 to SMTP07)

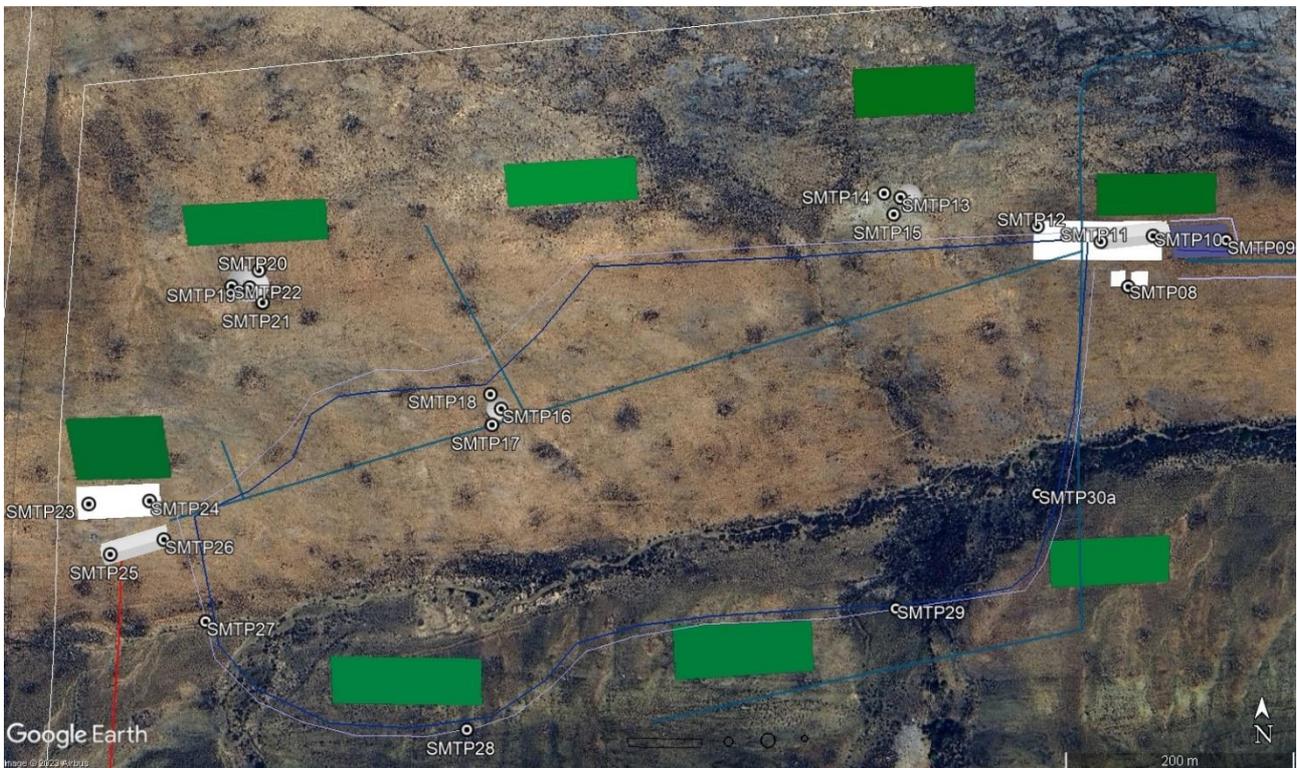
- SMTP08 – water storage and sewage infrastructure;
- SMTP09 – parking area;
- SMTP10 and SMTP11 – main building;
- SMTP12 – signal processing operations;
- SMTP13, SMTP14 and SMTP15 – 18 m to 24 m diameter satellite;
- SMTP16, SMTP17 and SMTP18 – 10 m diameter satellite;
- SMTP19, SMTP20, SMTP21 and SMTP22 – 34 m diameter satellite;
- SMTP23 and SMTP24 – power infrastructure;
- SMTP25 and SMTP26 – power generation building; and
- SMTP27, SMTP28, SMTP29 and SMTP30a – along road within LEGS communication facility.

Figure 3-2 Location of test pits within the LEGS communication facility area (SMTP08 to SMTP30a)

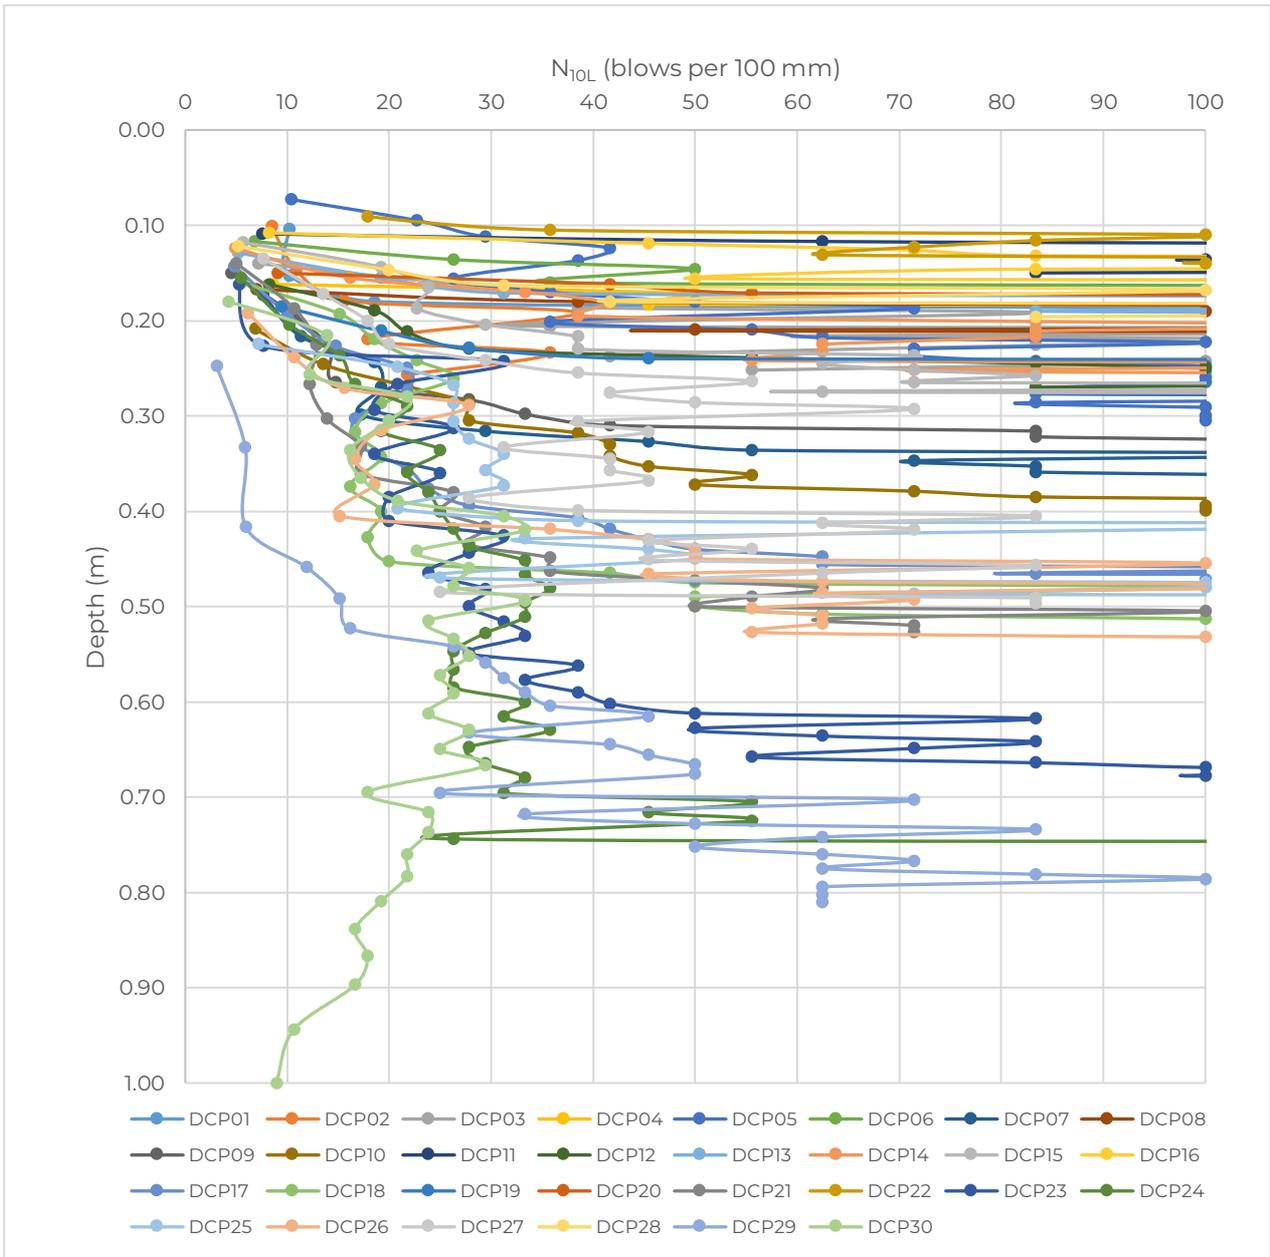
Figure 3-3 Scatter plot of N_{10L} versus depth for entire LEGS communication facility

The DCP profiles corresponds with the initial assumption made prior to executing the fieldwork that a thin soil profile was anticipated. For the majority of the DCP probes, the soil consistency was “loose” near surface, becoming “medium dense”. This rapidly increased to a “dense” consistency at bedrock level at depths between 0.10 m and 0.75 m below ground level. Shallow bedrock was encountered beneath the topsoil, which lead to the termination of twenty-nine (29 No.) DCP tests without managing to probe to 1.00 m below the surface.

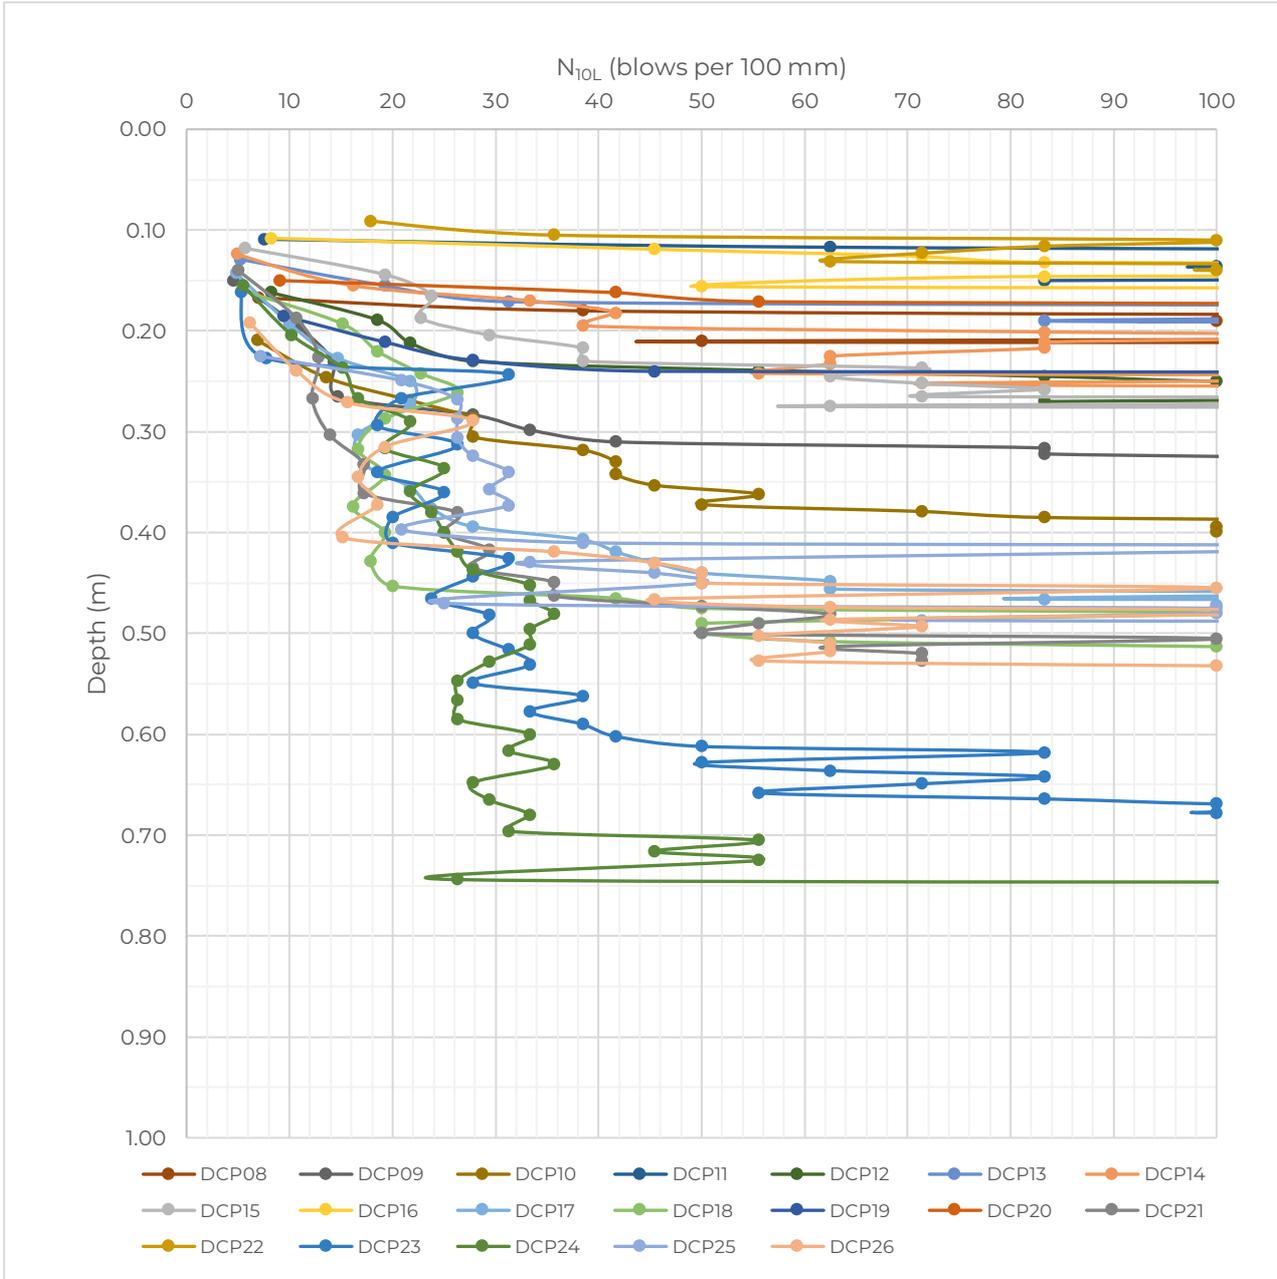
Figure 3-4 Scatter plot of N_{10L} versus depth for DCPs executed for proposed structures

The upper sand and gravel, hillwash transported, topsoil layer has a consistency ranging from “loose” to “medium dense”. The scatter plot follows a general trend exhibiting a steep increase in consistency from the topsoil to the shallow bedrock. DCP24 (executed adjacent to SMTP24) probed to a depth of 0.75 m before reaching refusal. This coincided with the soil layers observed during the excavations of SMTP24, where bands of completely weathered, very soft rock- and highly weathered, soft rock, tillite were first noted before moderately weathered, medium hard rock, tillite was observed from 0.80 m below ground level.

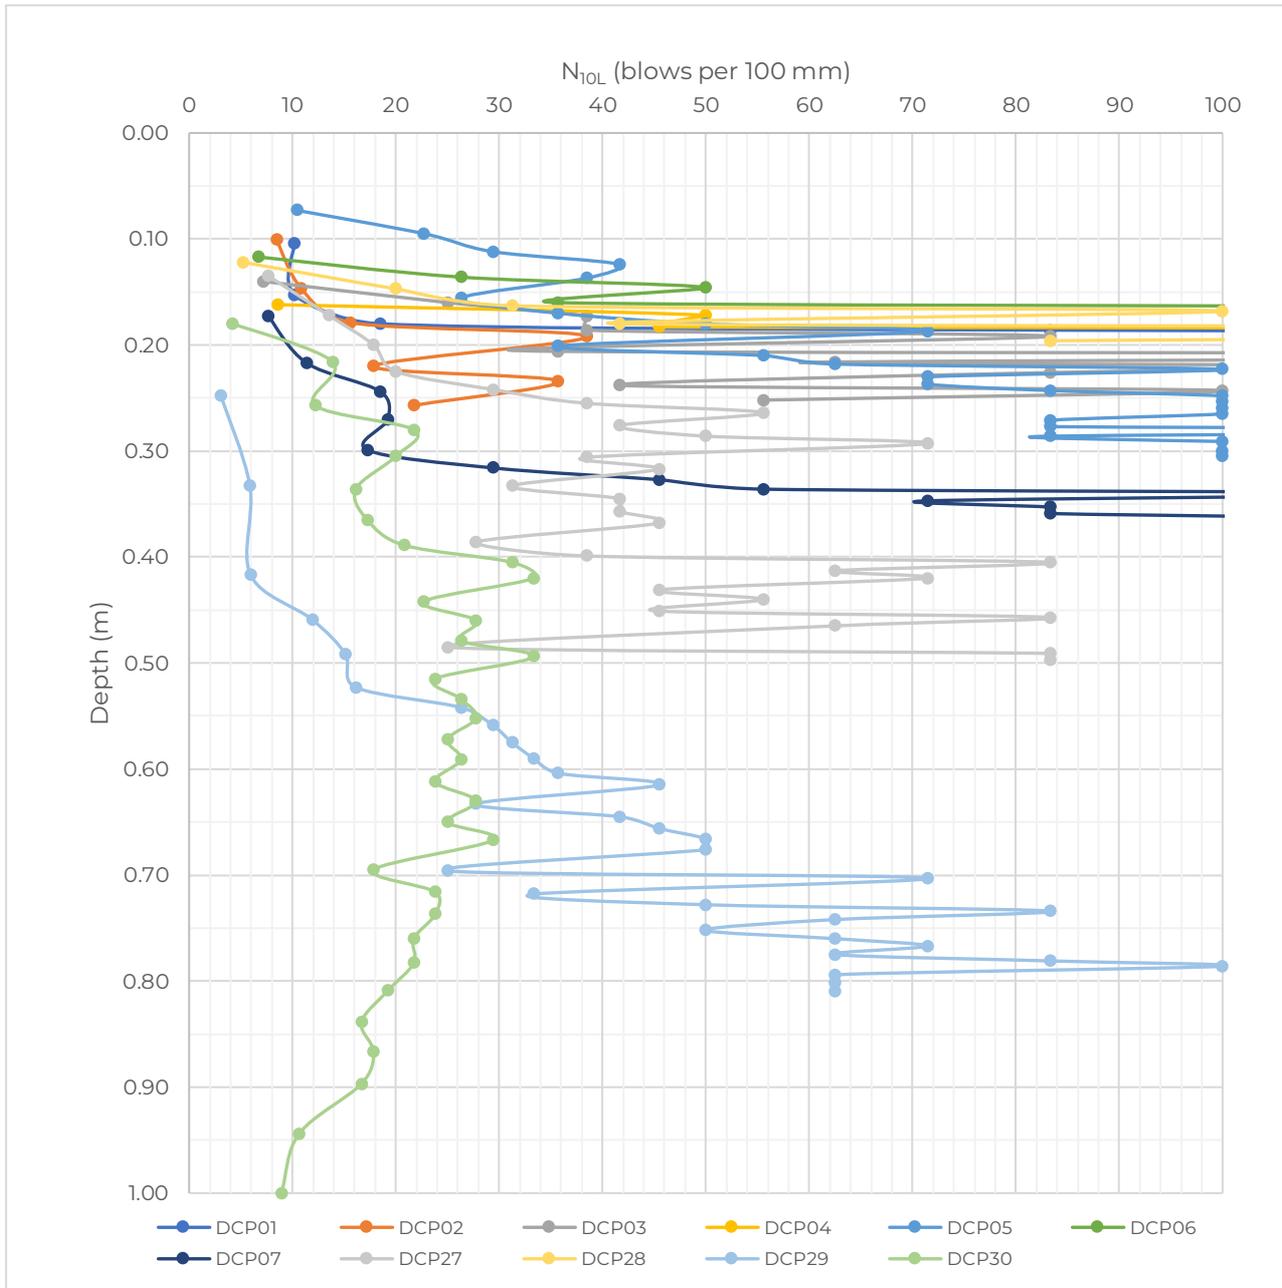
Figure 3-5 Scatter plot of N_{10L} versus depth for DCPs executed along the roads

For the majority of the DCP probes executed along the roads, a similar profile was observed as the DCPs for the proposed structures. However, at DCP27, DCP29 and DCP30 (the probes executed nearest to the relatively dry river bed running through the length of the site, where thicker hillwash and alluvium deposits were observed) the sand and gravel soils classified as “loose” to “medium dense” and “dense” with depth.

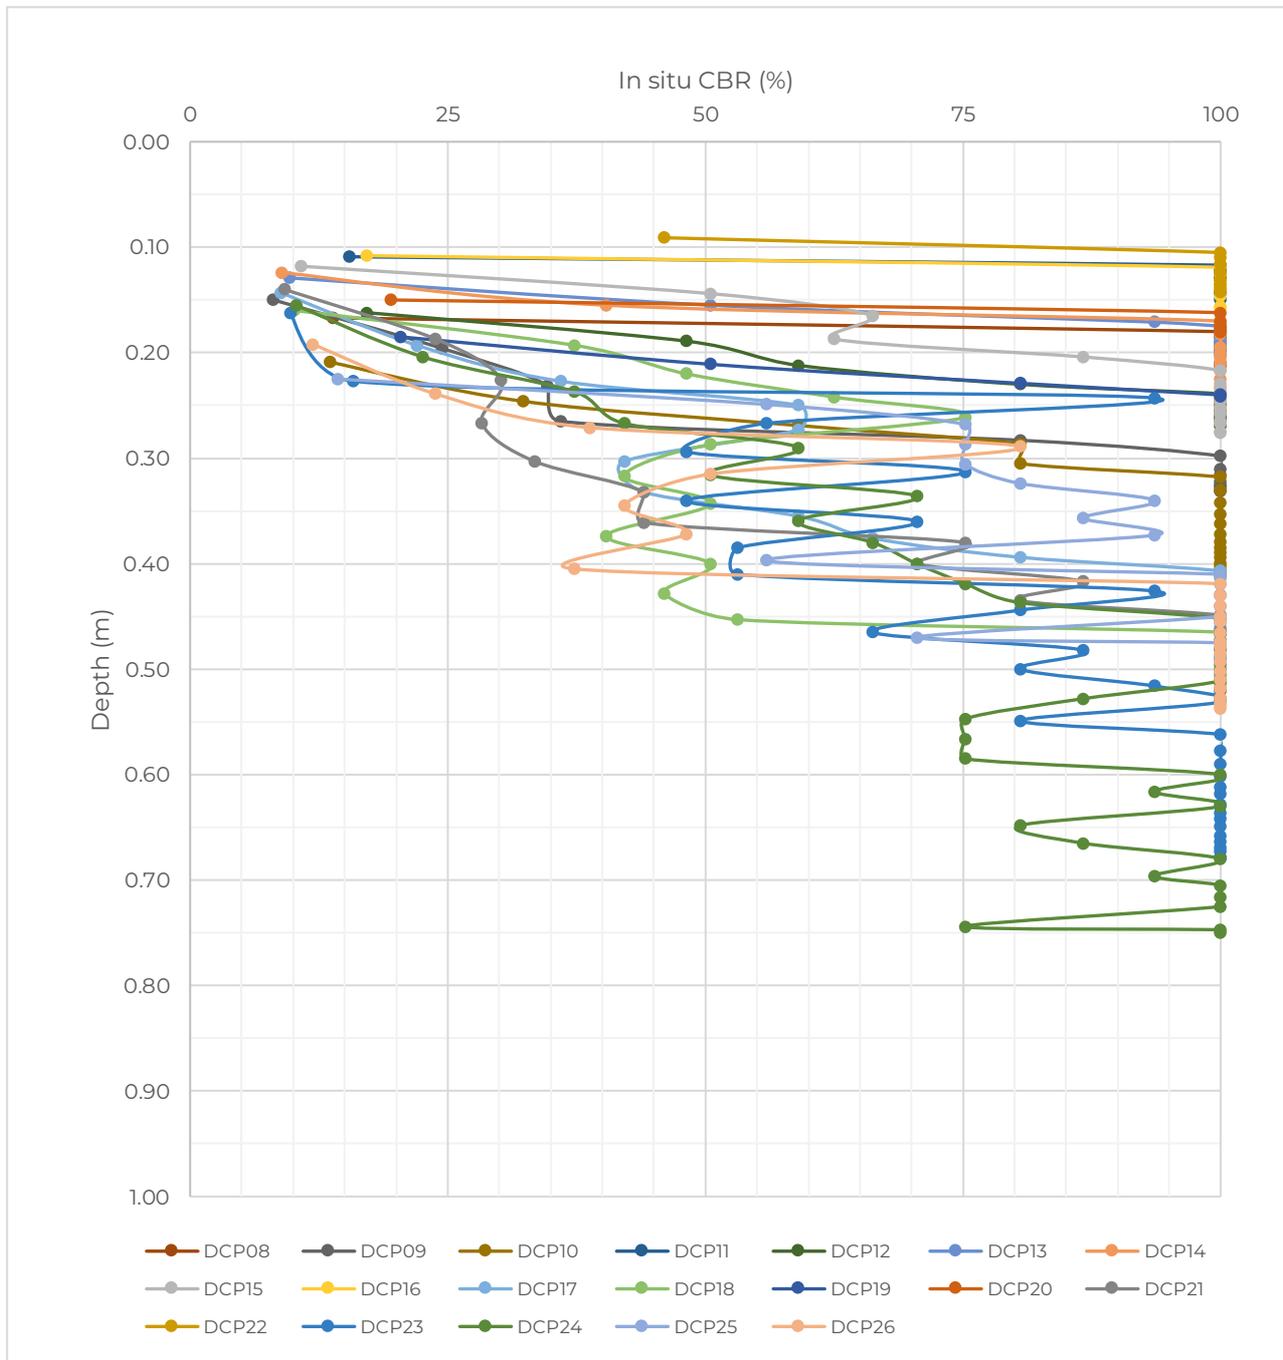
It must be noted that the results of DCP testing are influenced by the soil moisture content as well as the presence of gravel, cobbles and boulders within the soil profile. The DCP test results may also be influenced by shaft friction, particularly with depth. Based on these factors, the soaked CBR values obtained from the laboratory testing are considered to provide more reliable CBR values for the soils than the DCP test results.

Figure 3-6 In-situ CBR versus depth for DCPs executed for proposed structures

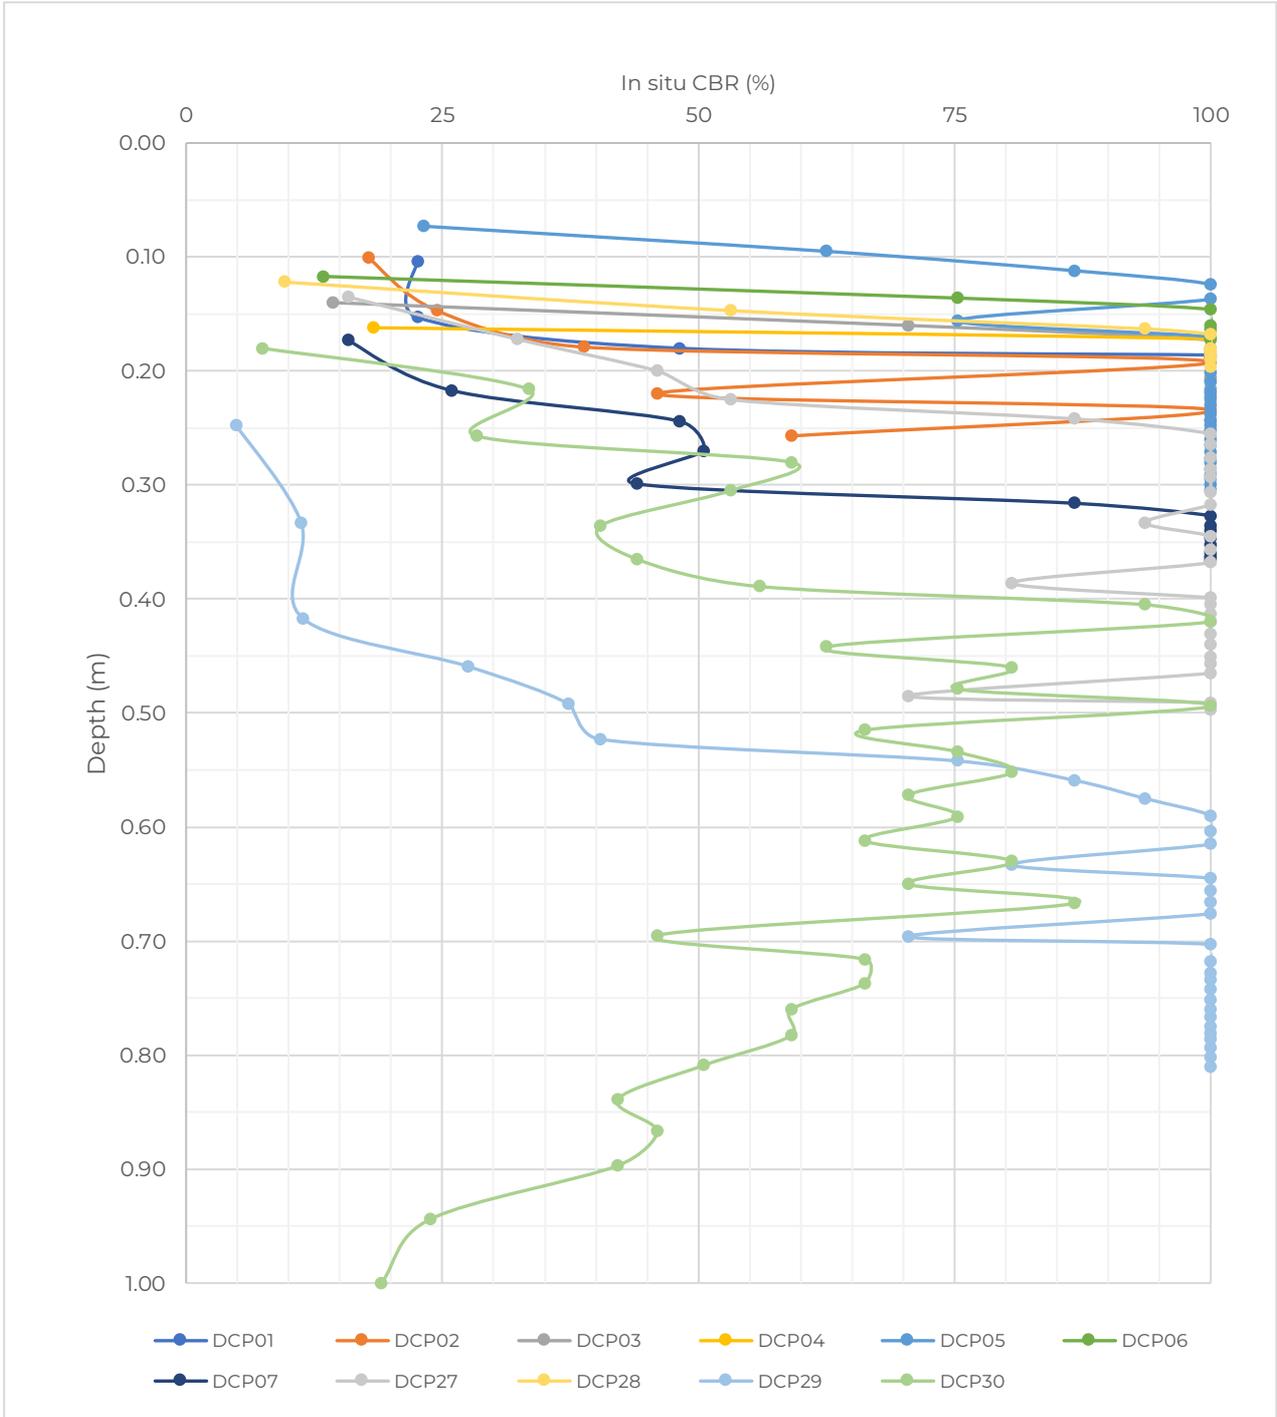
Figure 3-7 In-situ CBR versus depth for DCPs executed along the roads

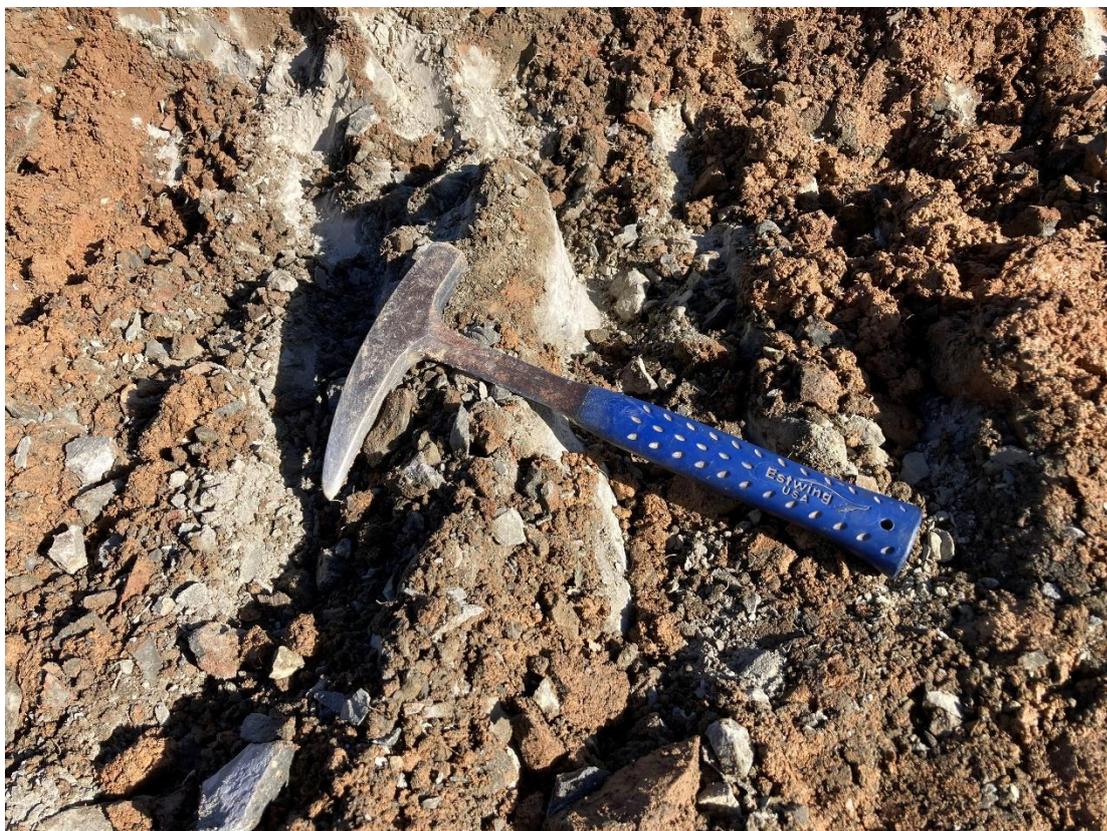
Figure 4 SMTP02 closeup of moderately weathered, medium hard rock, tillite

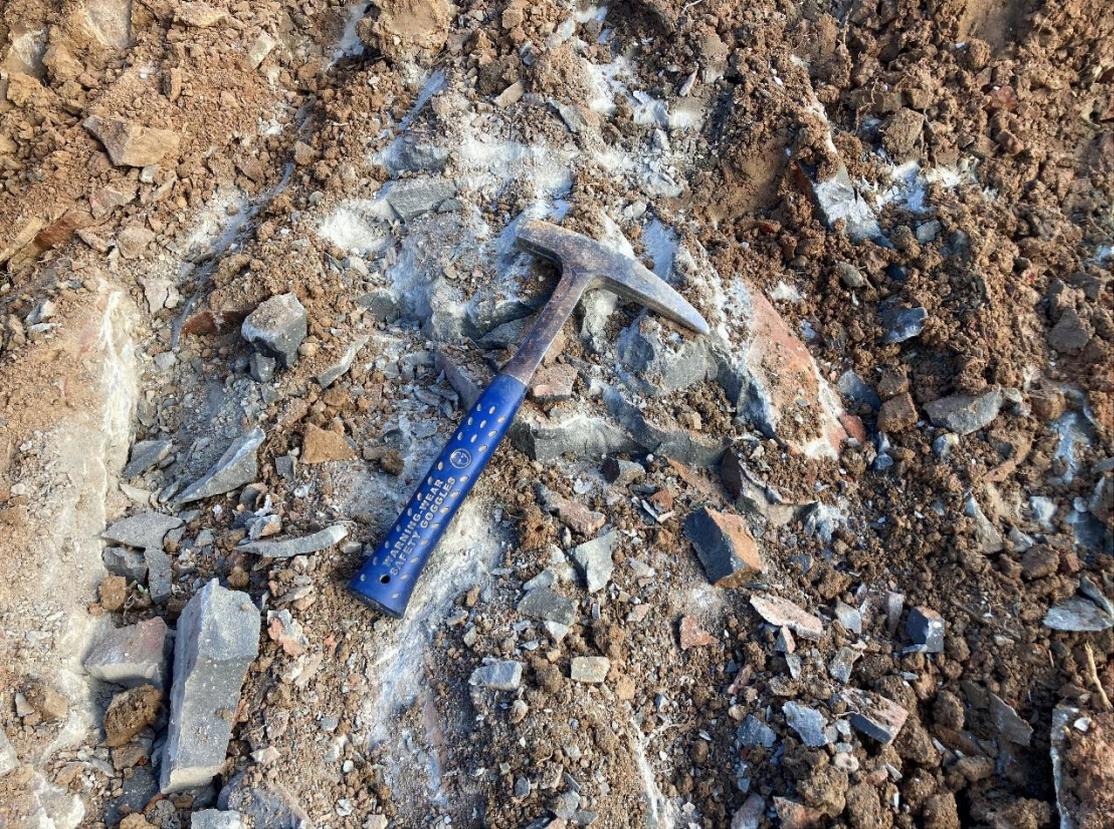
Figure 6 SMTP03 closeup of moderately weathered, medium hard rock, tillite

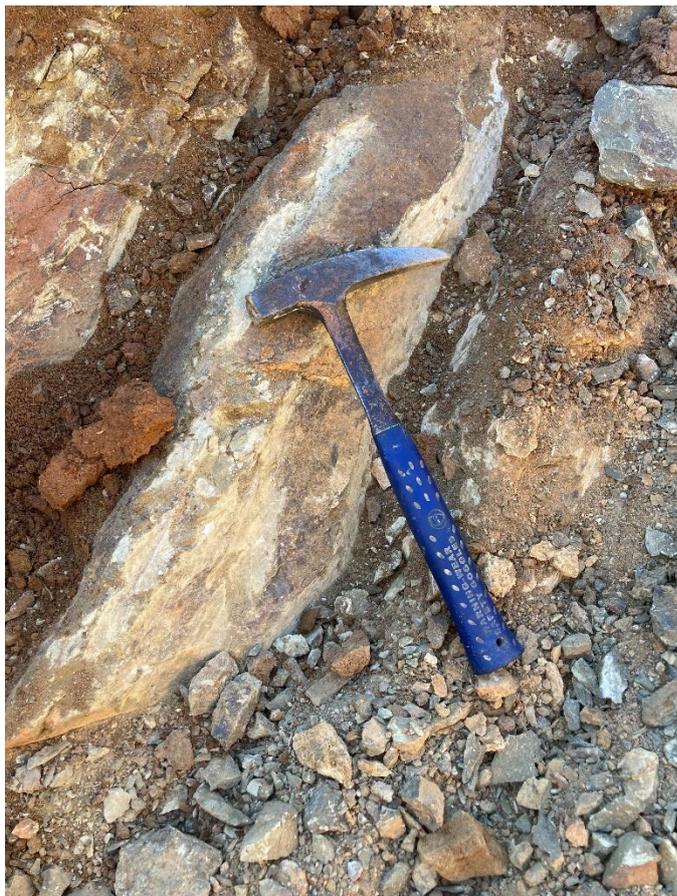
tillite

Figure 18 SMTP09 moderately weathered,

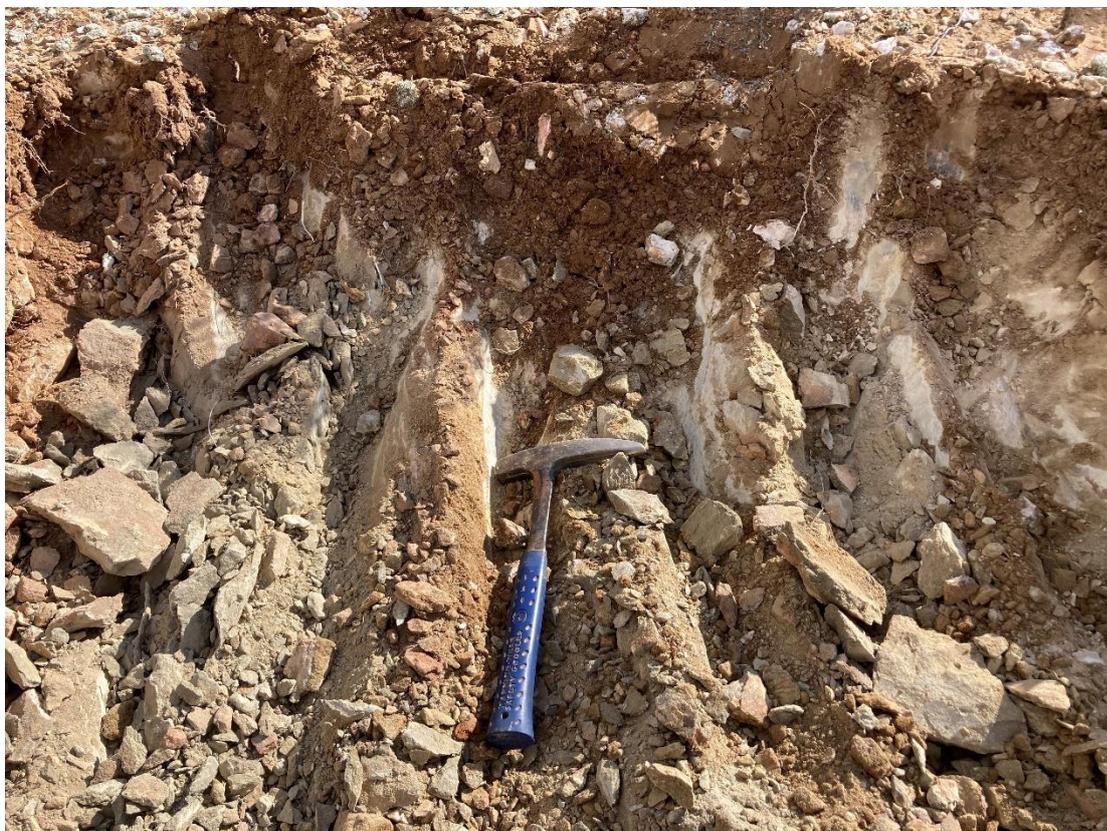
Figure 28 SMTPI4 moderately weathered, medium hard rock, tillite

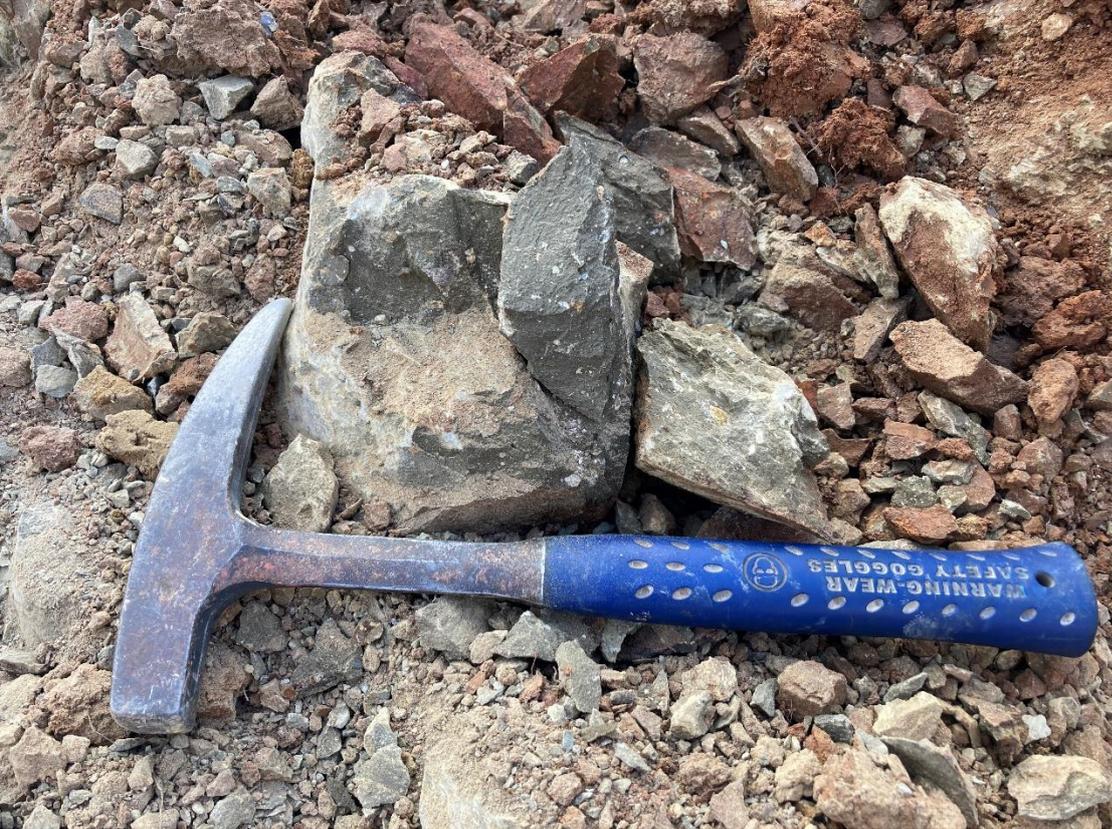
Figure 36 SMTPI8 closeup of moderately weathered, medium hard rock, tillite

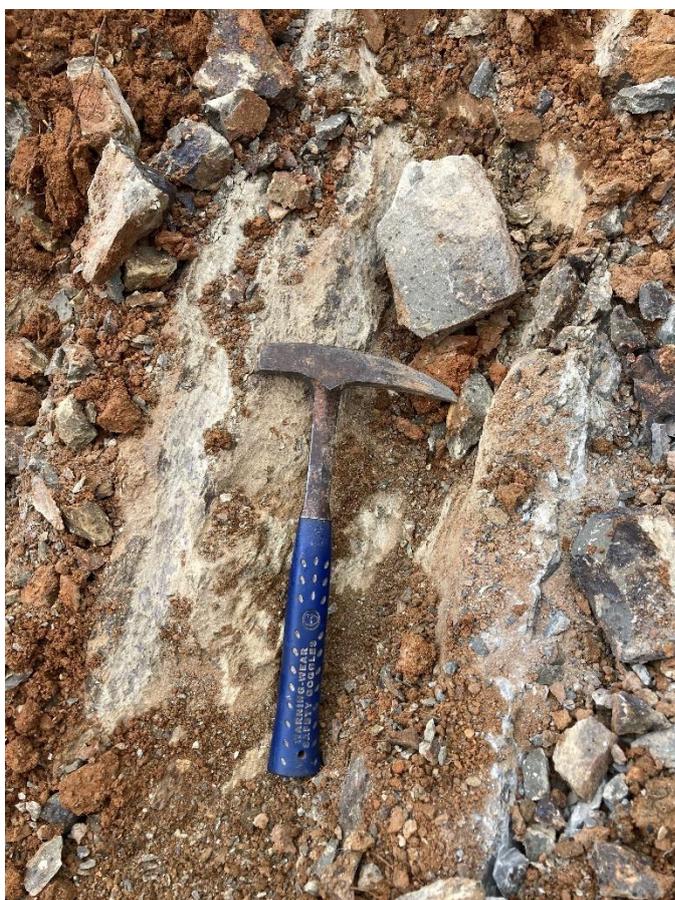
tillite

Figure 50 SMTP25 moderately weathered,

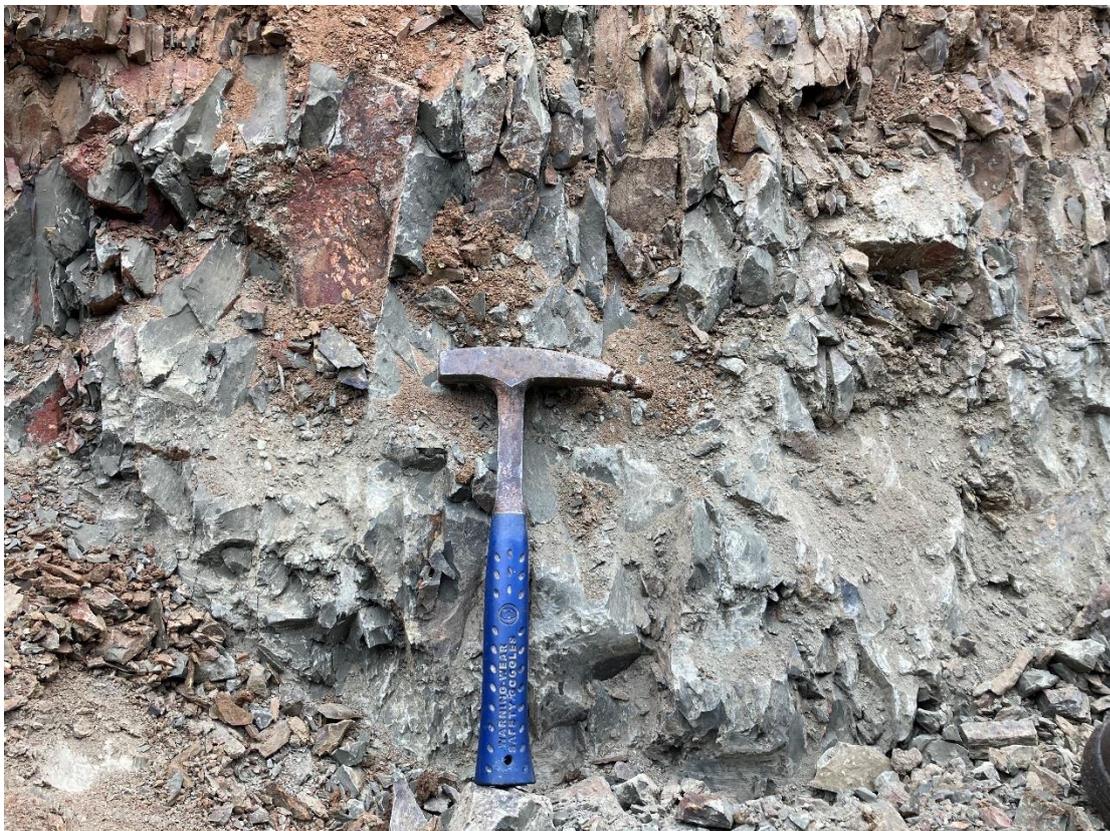
It must be noted that a change in geology was observed in SMTP28. The profile exhibited a upper hillwash transported clayey **Sand** layer with occasional angular, elongated, mudrock fine to coarse gravel, which had a “loose” to “medium dense” consistency. This was underlain by a **Gravel** layer described as *slightly moist, dark brown to grey, clast supported, angular to sub-angular, elongated, mudrock fine to coarse gravel, with clayey sand as above*. The consistency was described as “medium dense”. The TLB reached refusal in a layer of *grey, streaked white, stained red and brown, moderately weathered, very fine grained, laminated, highly jointed, medium hard rock, Mudrock*. The joints were noted as narrow, and were stained and filled with clayey sand. The cobble to boulder sized excavations slowed the TLB progress and eventually incurred refusal.

Figure 56 SMTP28 closeup of moderately weathered, medium hard rock, mudrock
